Il restauro della facciata della chiesa di Santa Maria di Nazareth a Venezia

Criteri di analisi, rilievo, diagnostica e sperimentazione nel cantiere di restauro

Restauro della facciata della Chiesa di Santa Maria di Nazareth (vulgo degli Scalzi) in Venezia

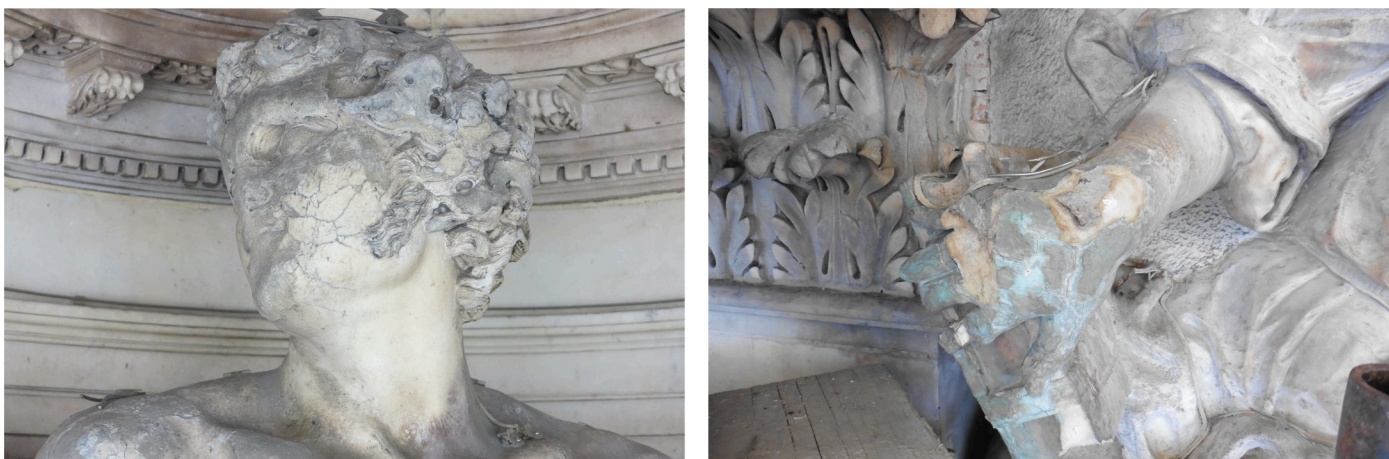
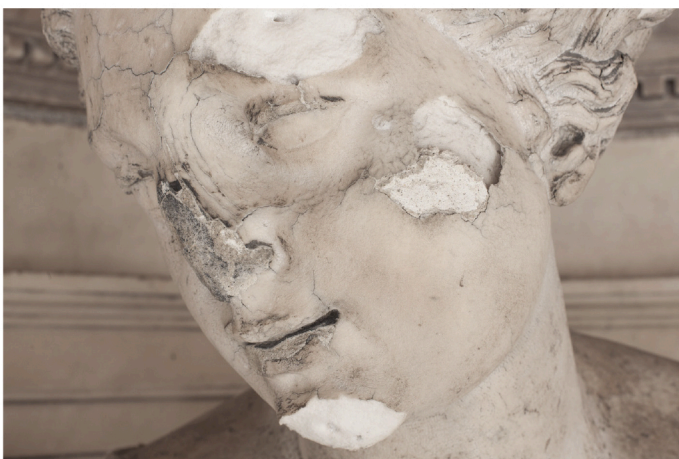
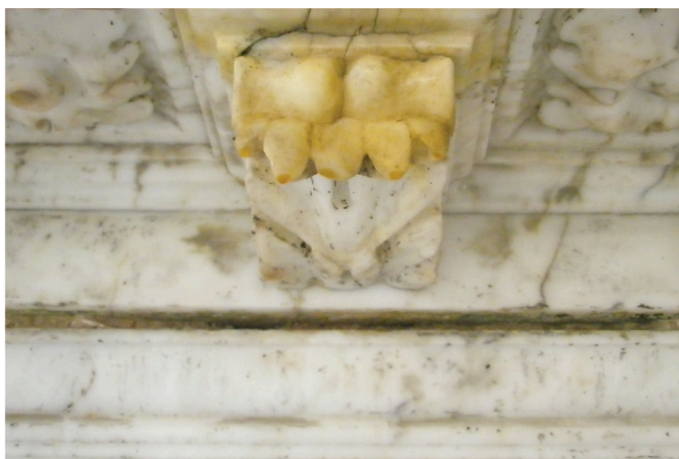
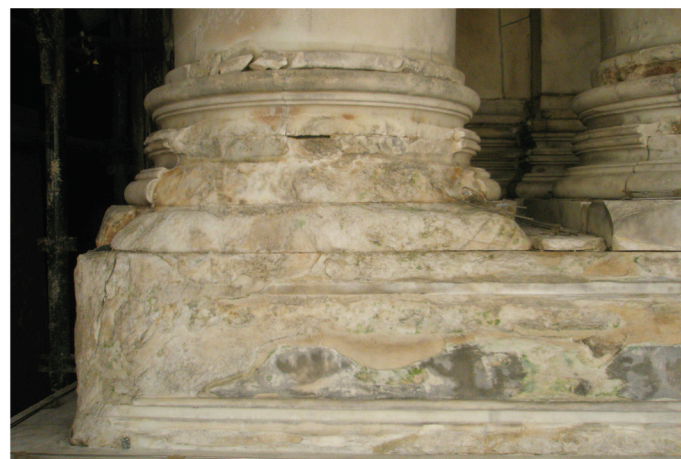
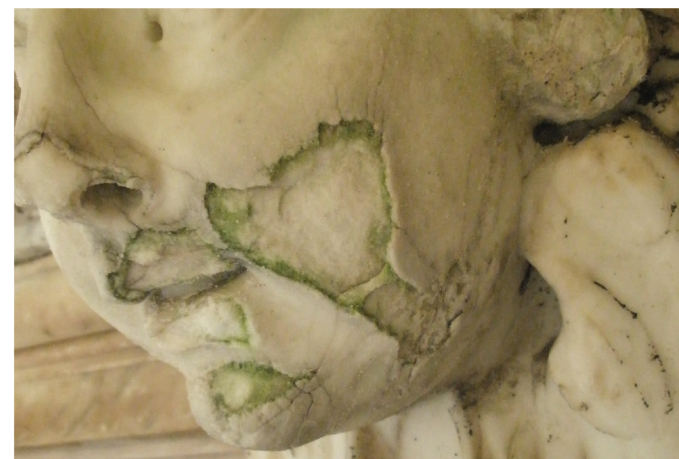
Representative images of the different states of degradation

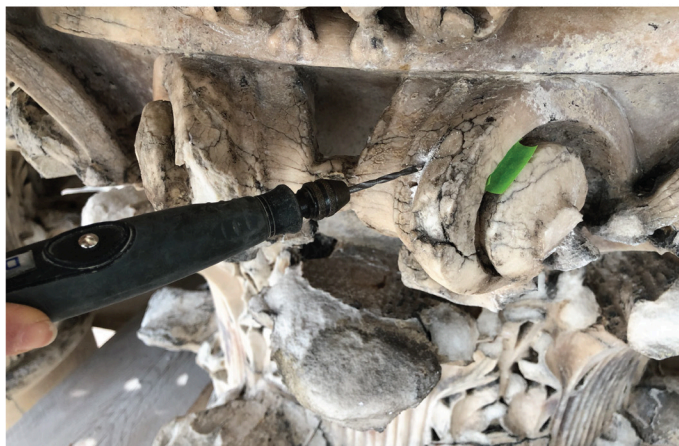
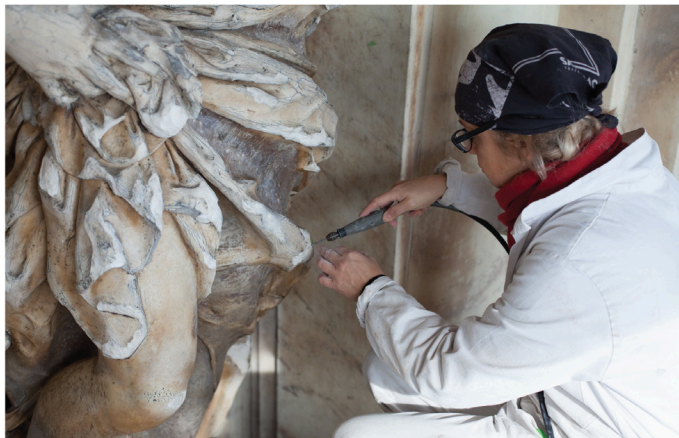
Drilling

Since the marble was so compromised that it could barely bear the minimum mechanical stress, a careful chemical and physical diagnostic campaign was undertaken. A series of drilling tests were performed to identify the depth of the degradation, mapping the entire area of the facade. In fact, it emerged that in some points the material was compromised up to 12 cm.

Furthermore, the dust returned by the drilling tests was used to obtain different samples for chemical diagnostic analysis.

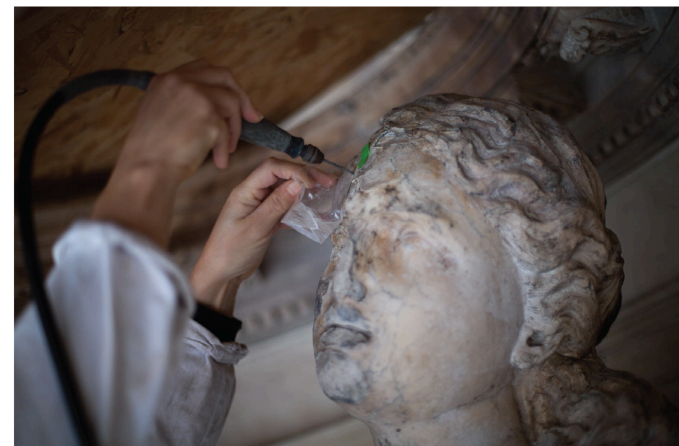
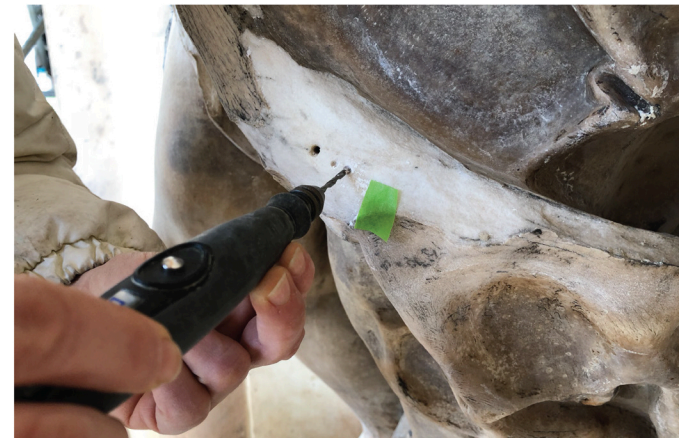
Elements treated with experimentation consolidation

Ten test areas have been identified to carry out the treatments to be tested. The areas were chosen on the basis of two criteria: the degree of exposure of the marble on the facade and the representativeness of all types of degradation present.

The consolidating agents that have proved to be the most suitable are the nanosilica –which has the advantage of being compatible with the marble– and the combined use of ethyl silicate, a product traditionally and widely used for the

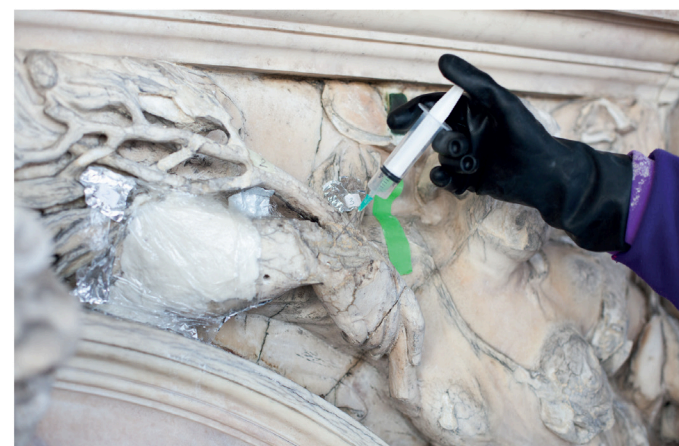
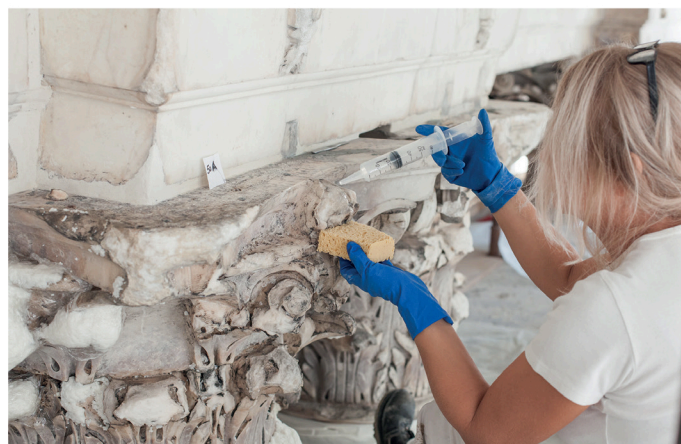
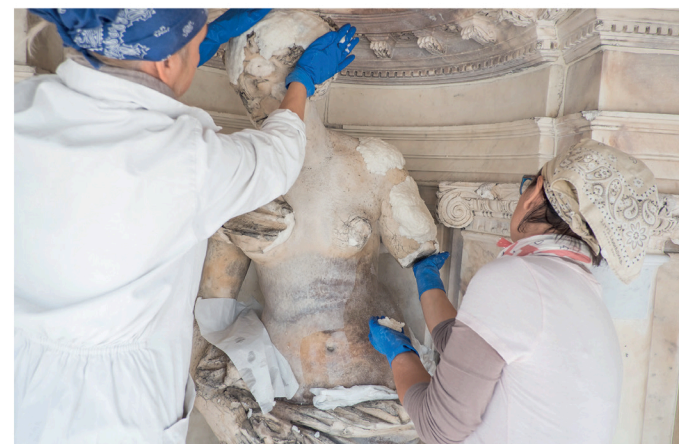
Before and after the intervention of experimental consolidation

The choice of the consolidating agent, the application method and the verification of the performance was supported by experimentation both on site, choosing the sample area to be treated, and in the laboratory. The application of materials based on nanoparticles has been tested because the small size of the particles allows a good penetration of the consolidating agent.
